Lake Sarah Meeting

August 26, 2004

Tom Hovey
DNR Waters

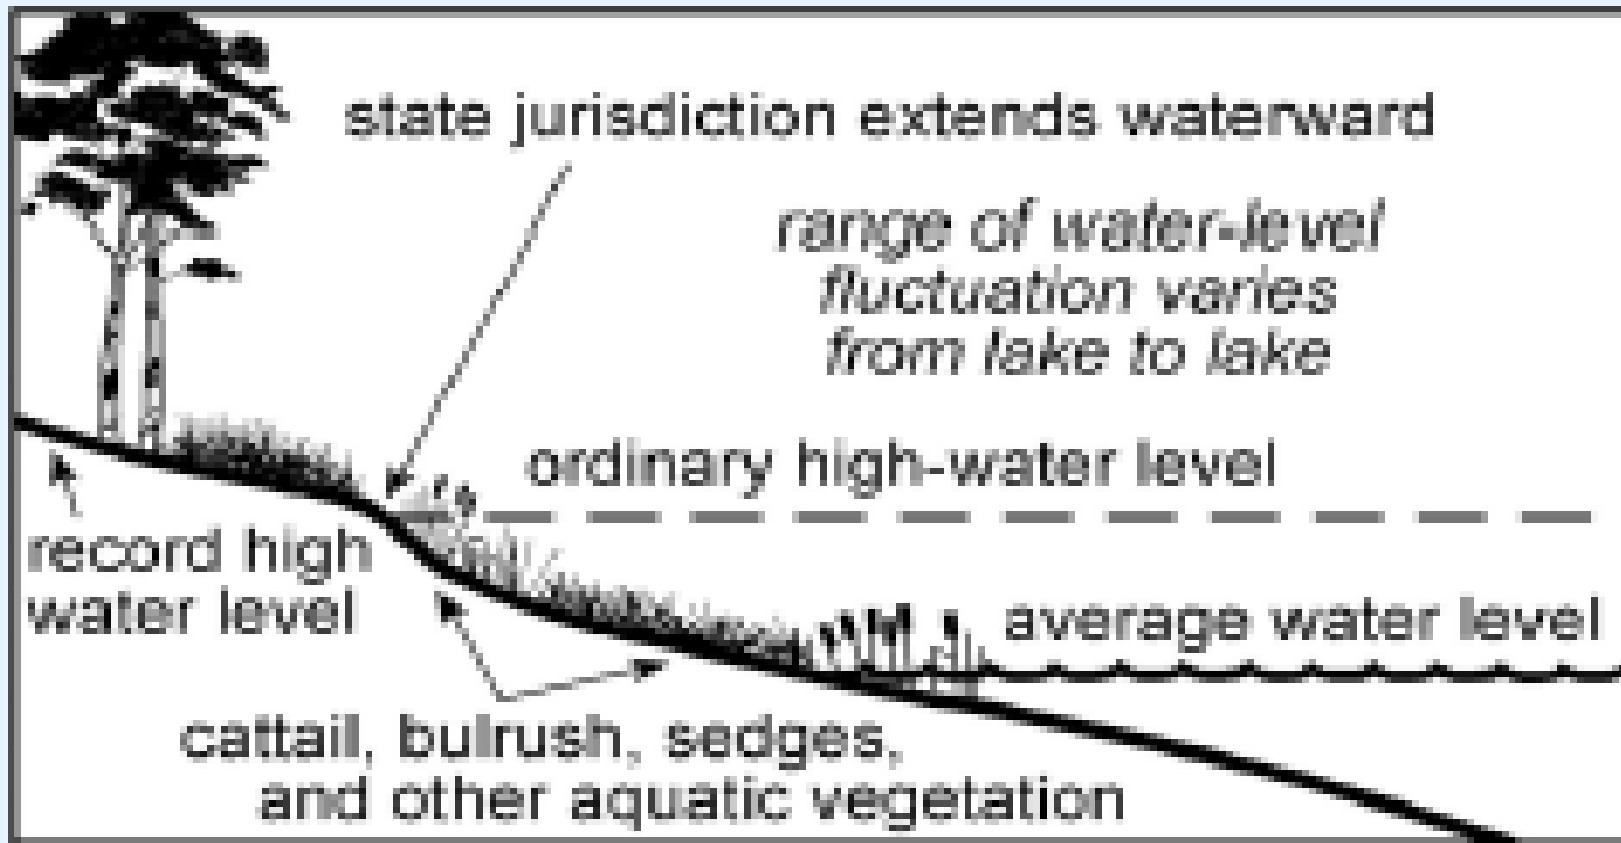
Ordinary High Water Level

- Elevation 979.9' (formerly 979.5')
- Boundary of public waters and p.w. Wetlands
- An elevation...highest water level that has been maintained for a sufficient period of time to leave evidence on the landscape

Shoreline cross section.

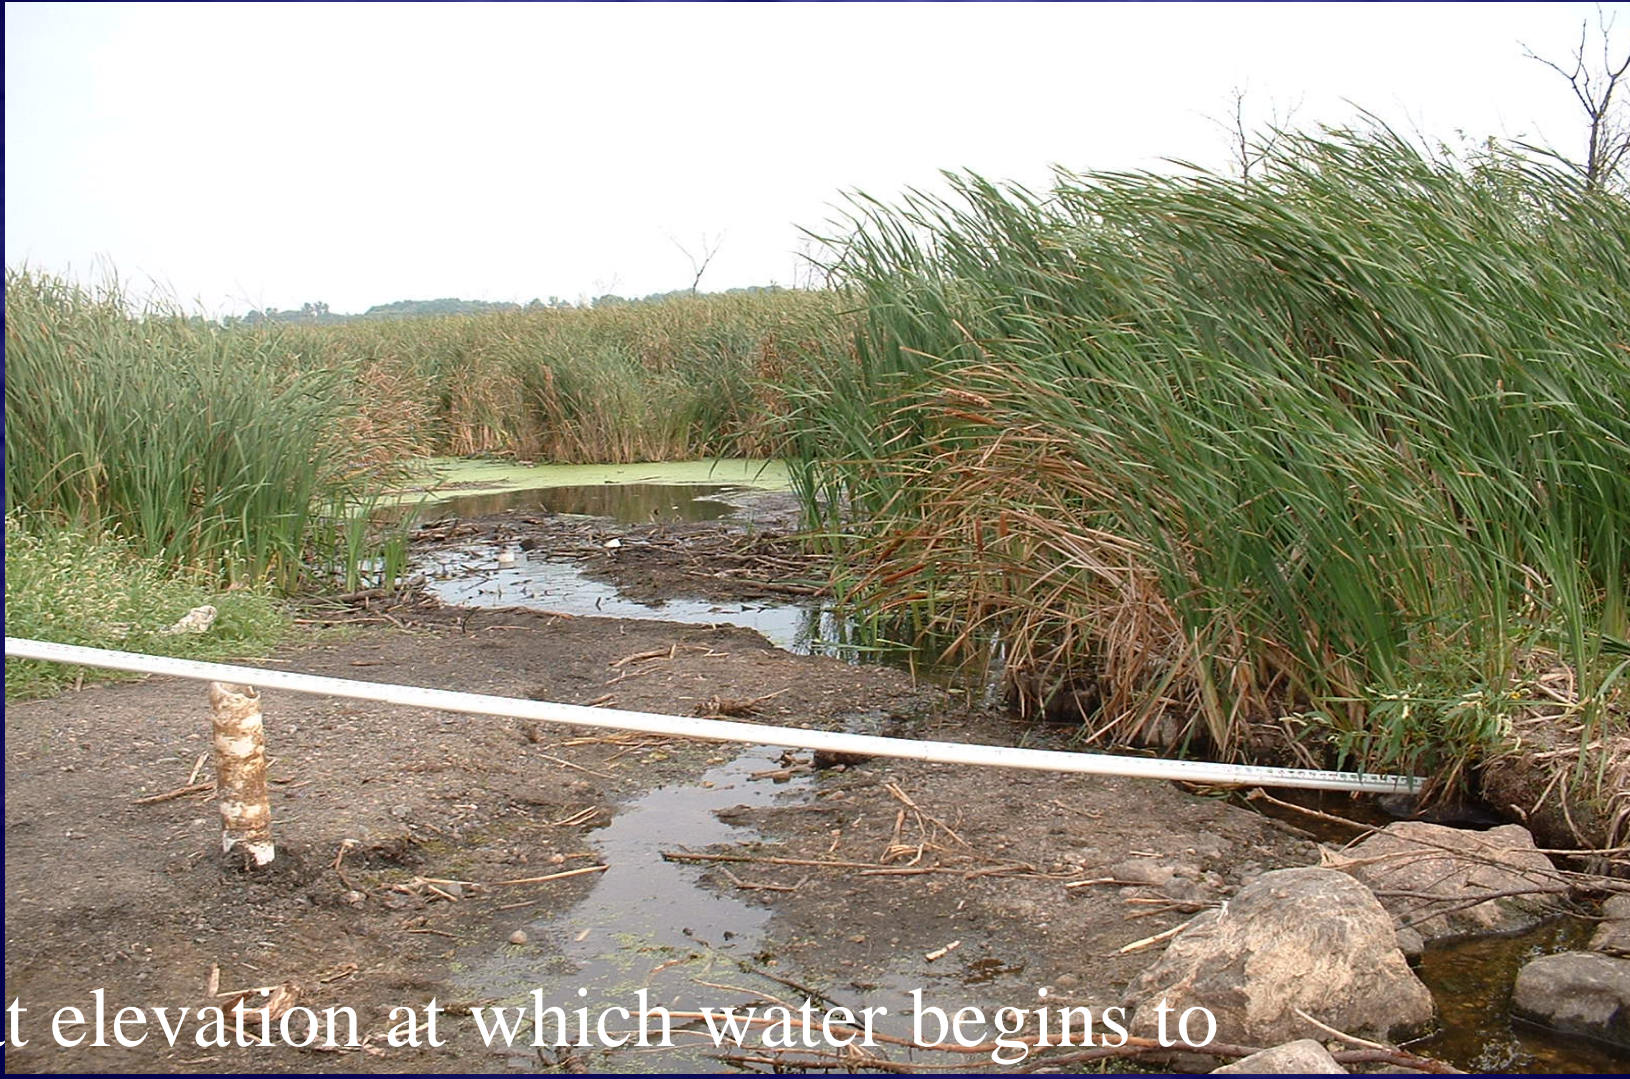
Runout Elevation

That elevation at which water begins to
flow out of a basin

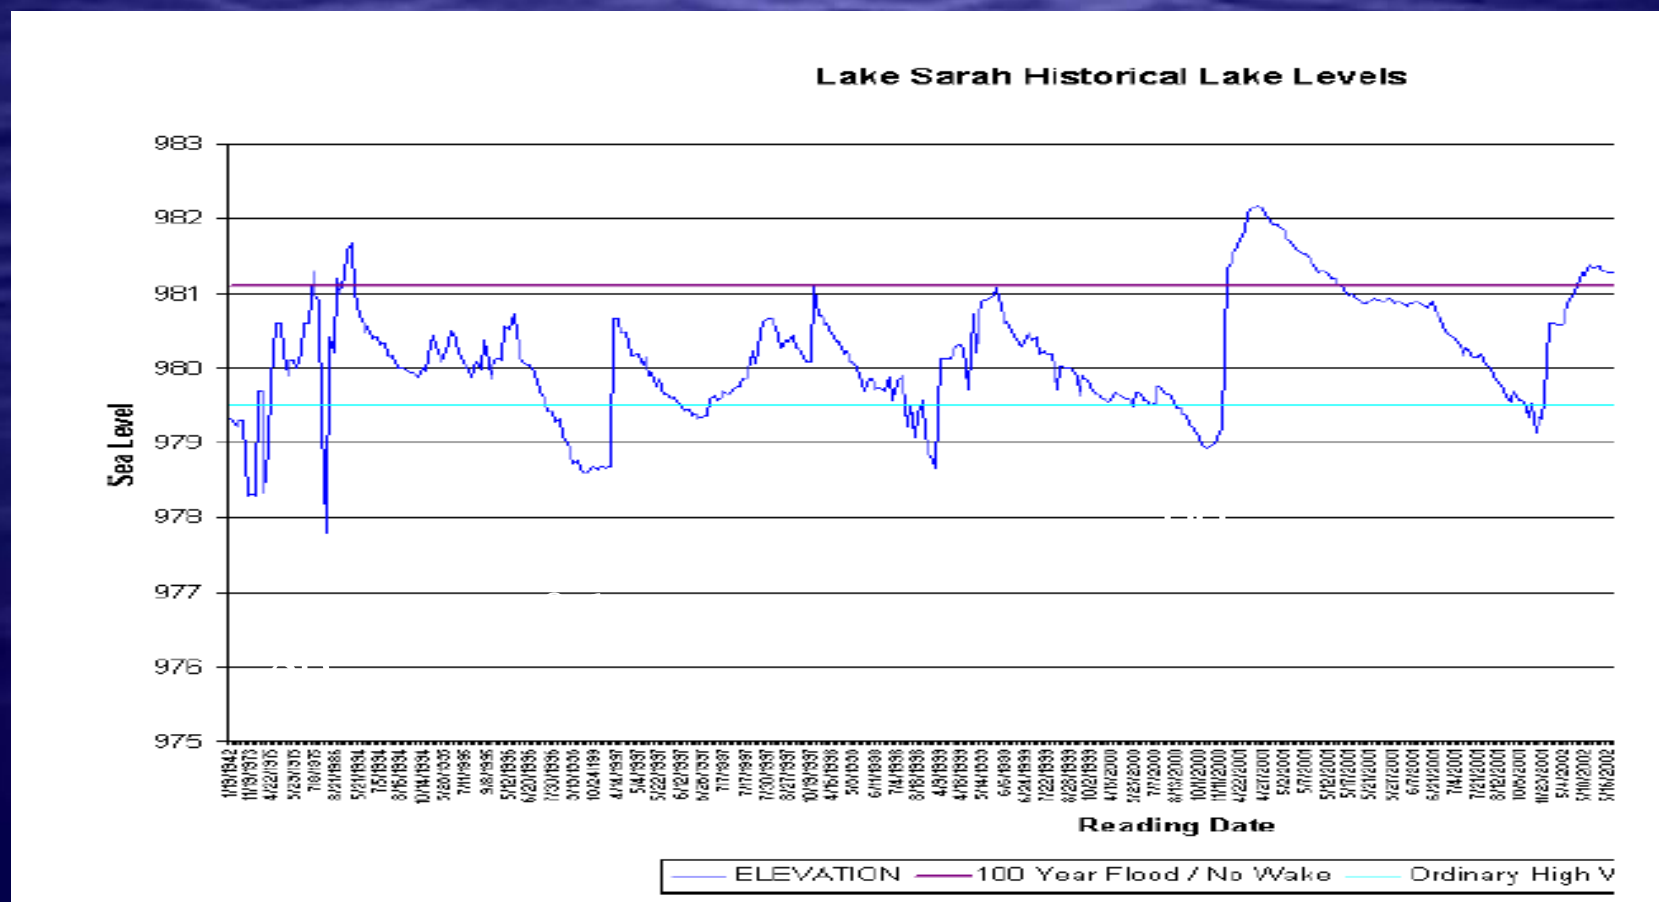
Historic Lake Levels thru '02

- 100 year flood elevation - 981.2'
- Ordinary High Water Elevation – 979.9'
- Outlet Elevation (2003) – 979.3'
- Approximate Runout Elevation Today – 978.5'
- Water Surface Today (8/26/04) – 978.8'
- Suggested Range – 978.3' to 978.8'
- Runout Elevation (1986) – 978.2'
- Runout Elevation (1974) – 977.9'
- Runout Elevation (1942) – 977.3'

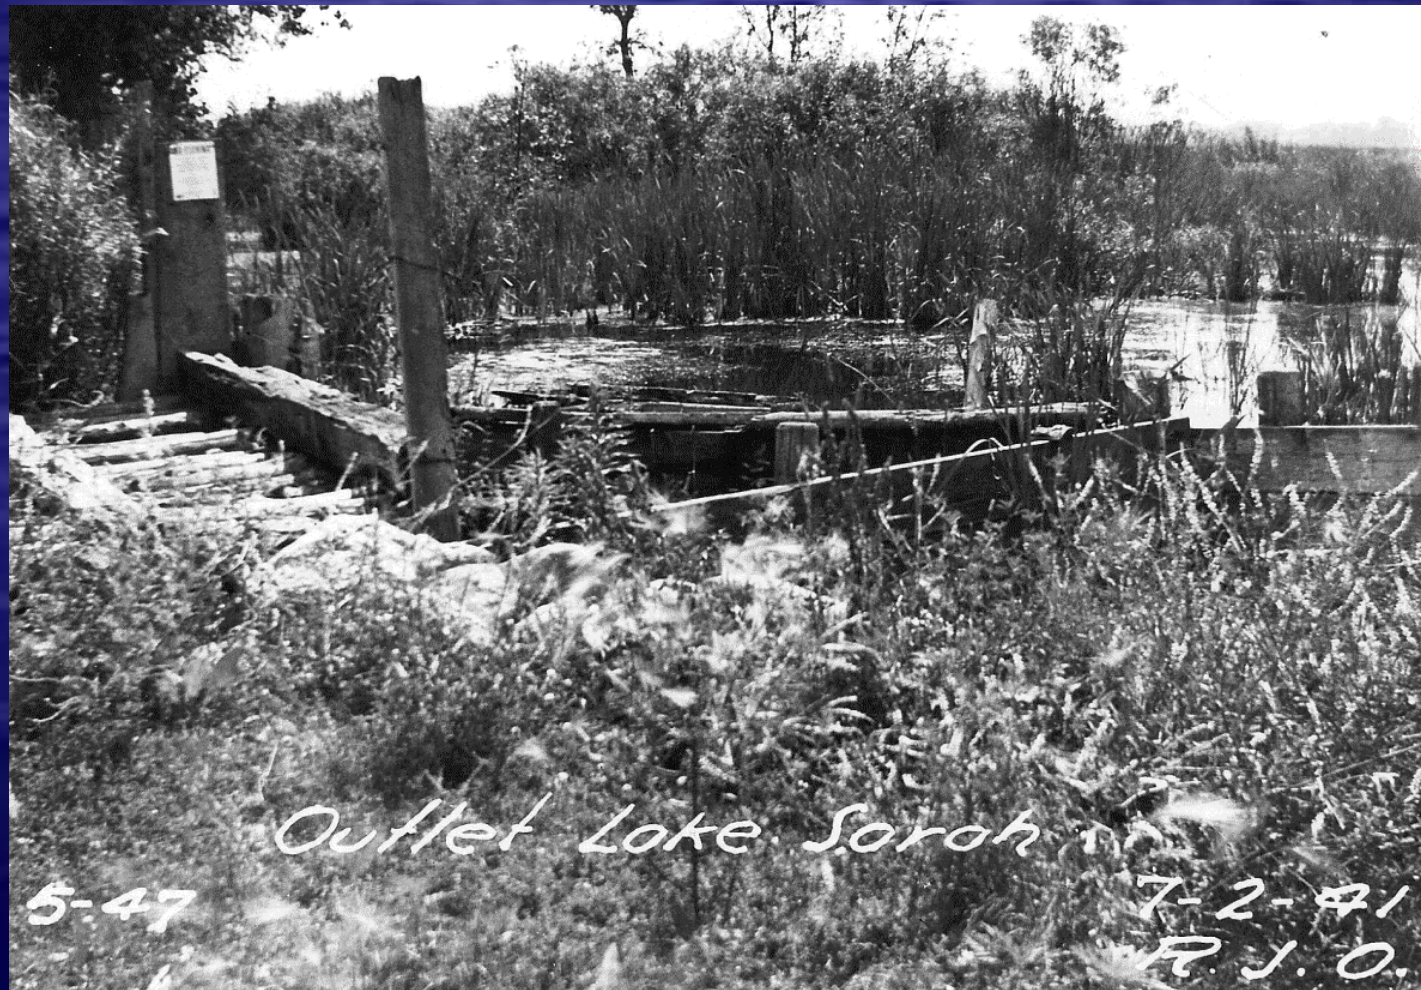
Lake Sarah Outlet - 1941

Outlet Lake Sarah

7-2-41

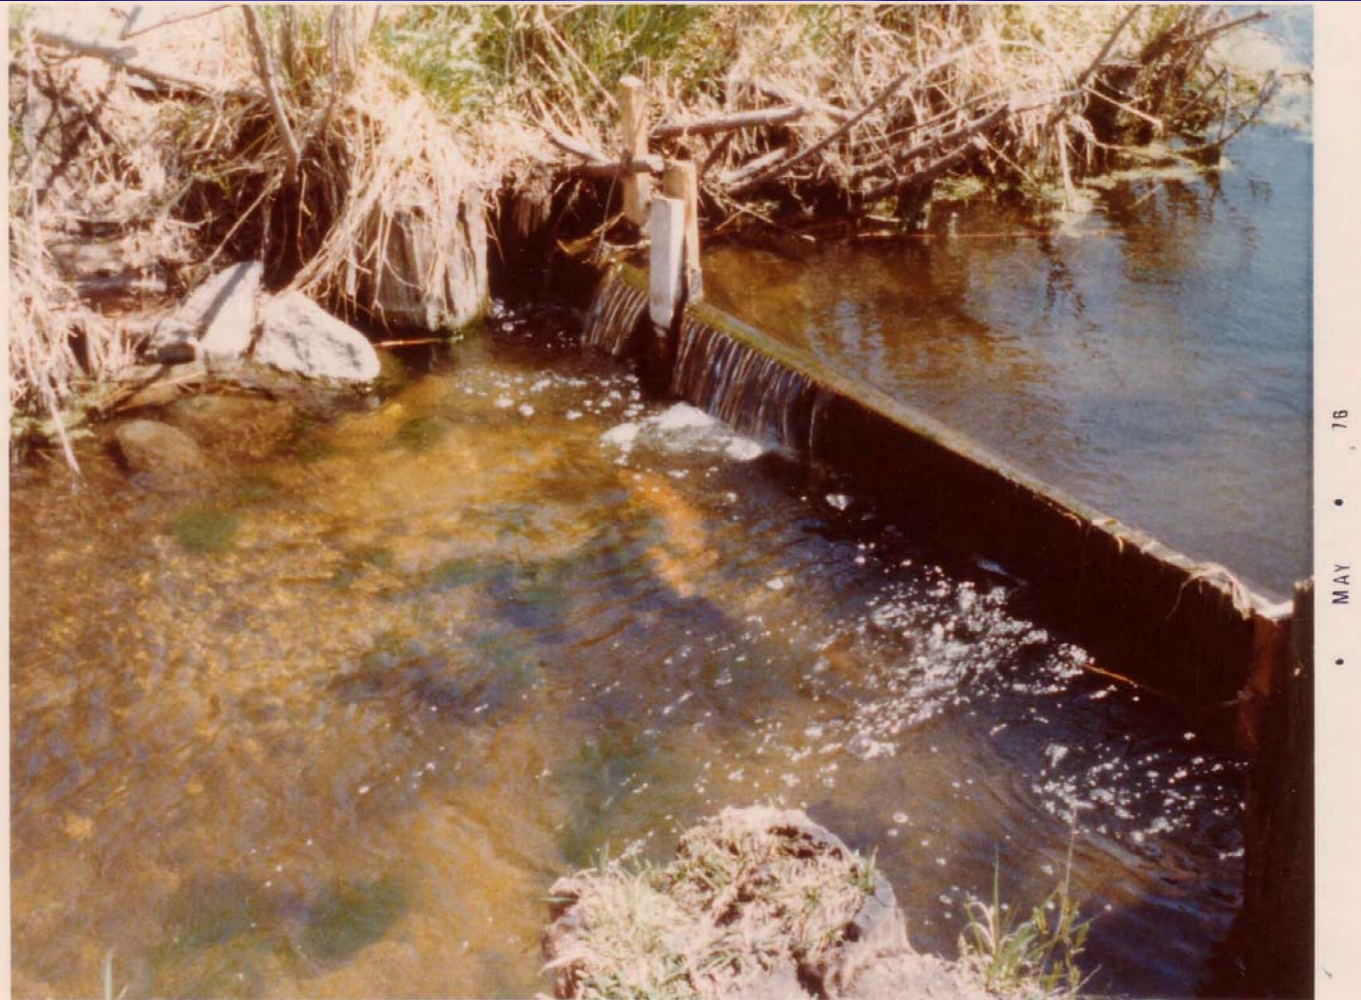
Lake Sarah Outlet - 1976

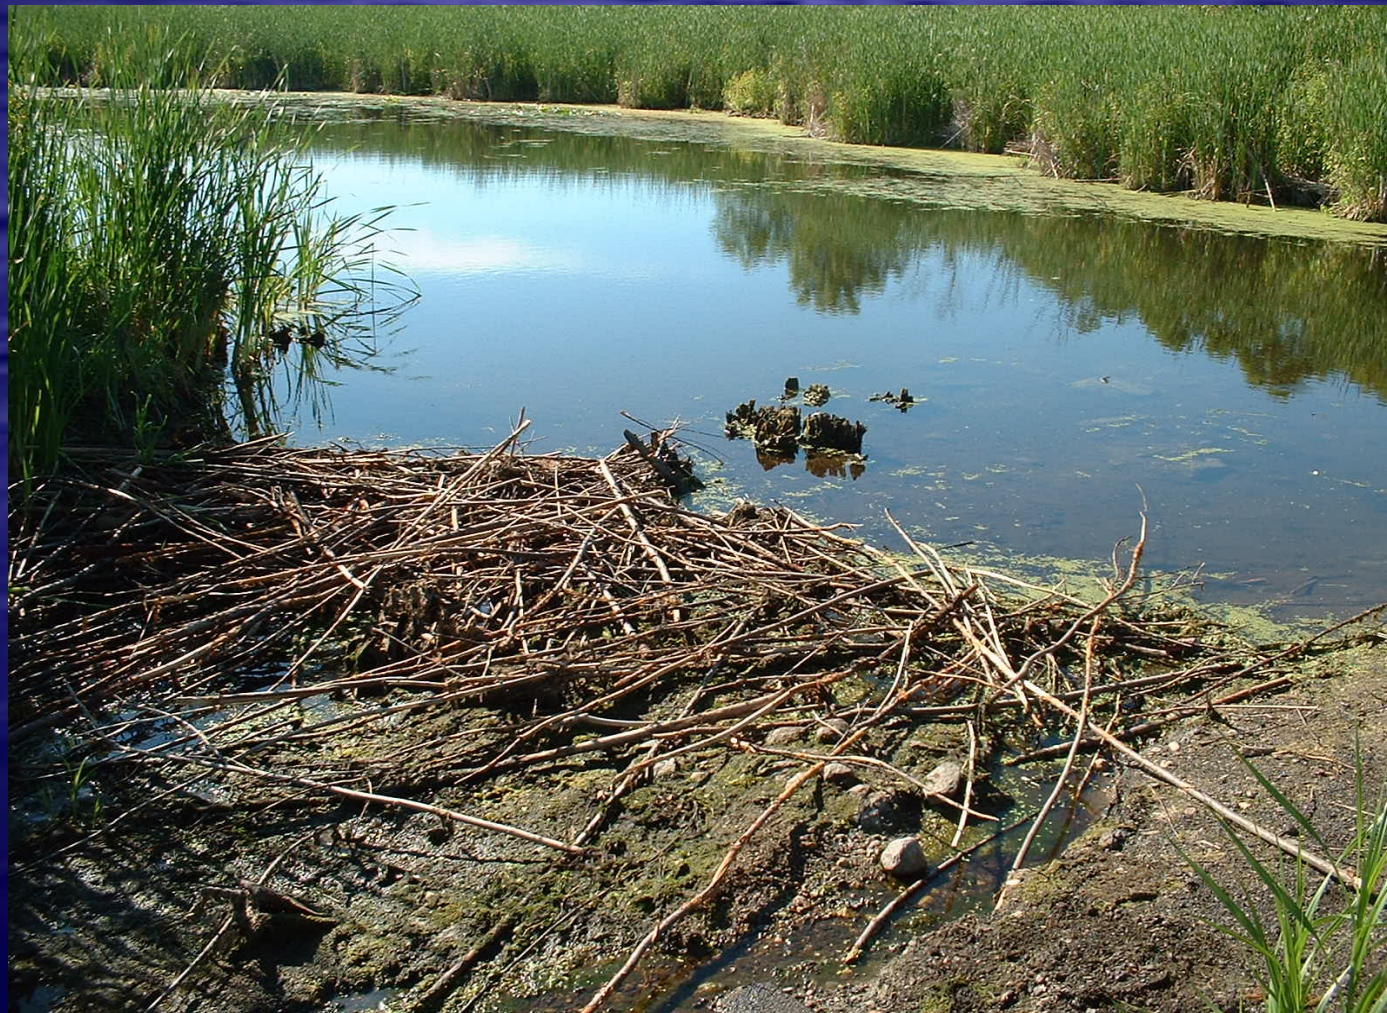
Lake Sarah Outlet - 2004

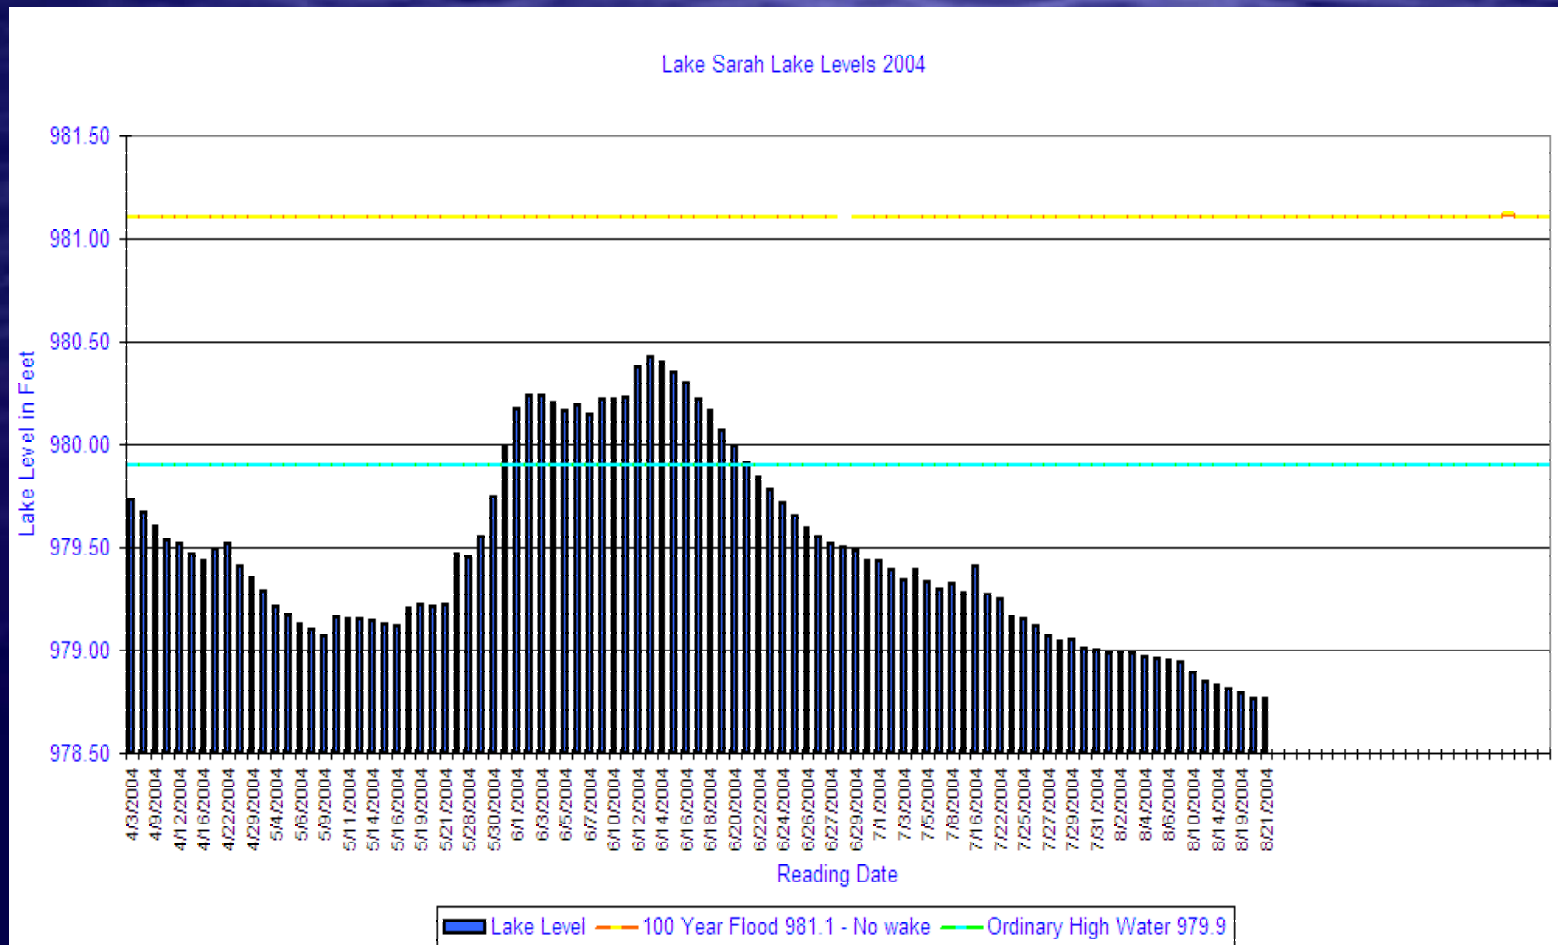
Water Levels - 2004

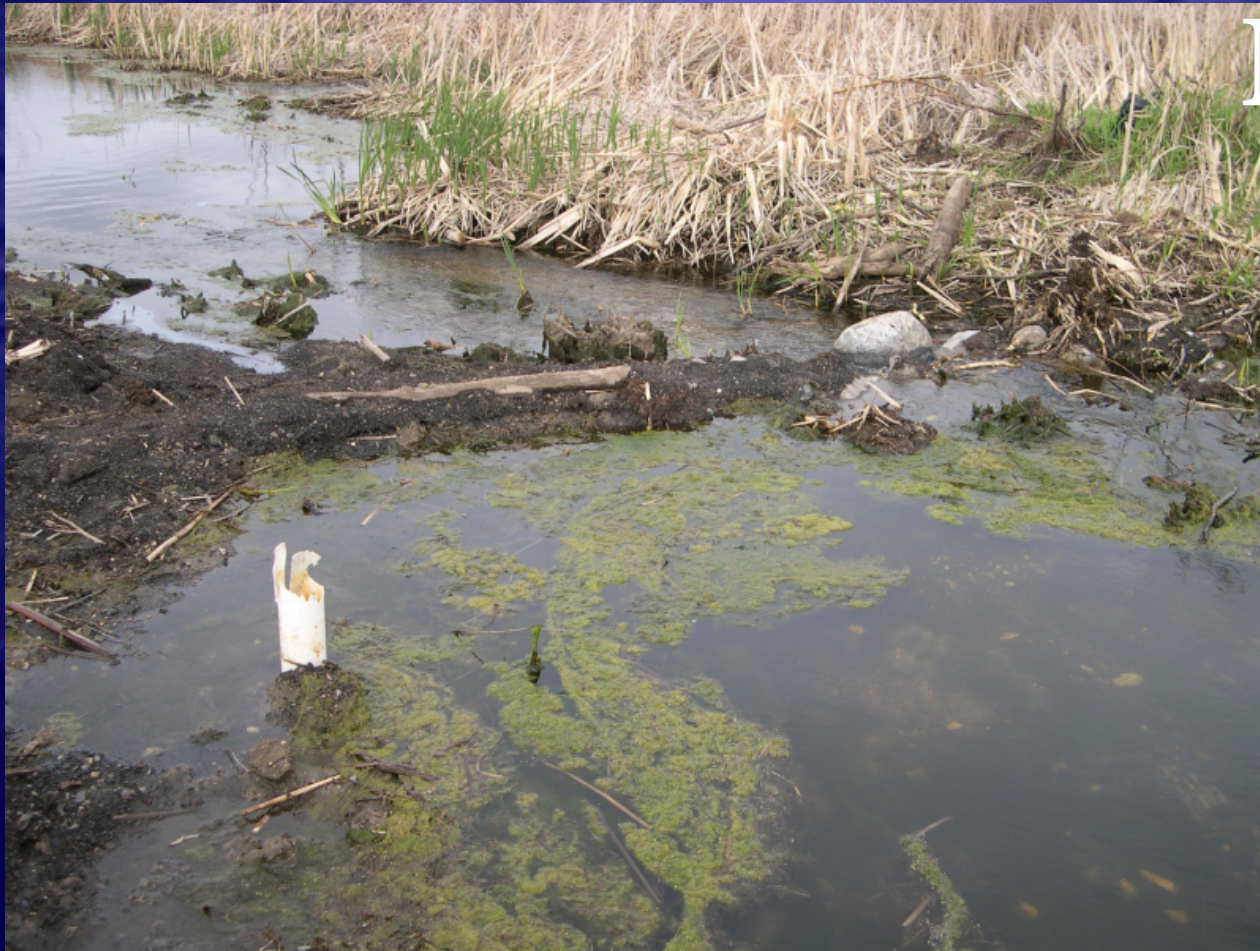
Unauthorized Alterations

May 2004

- More harm
than good?

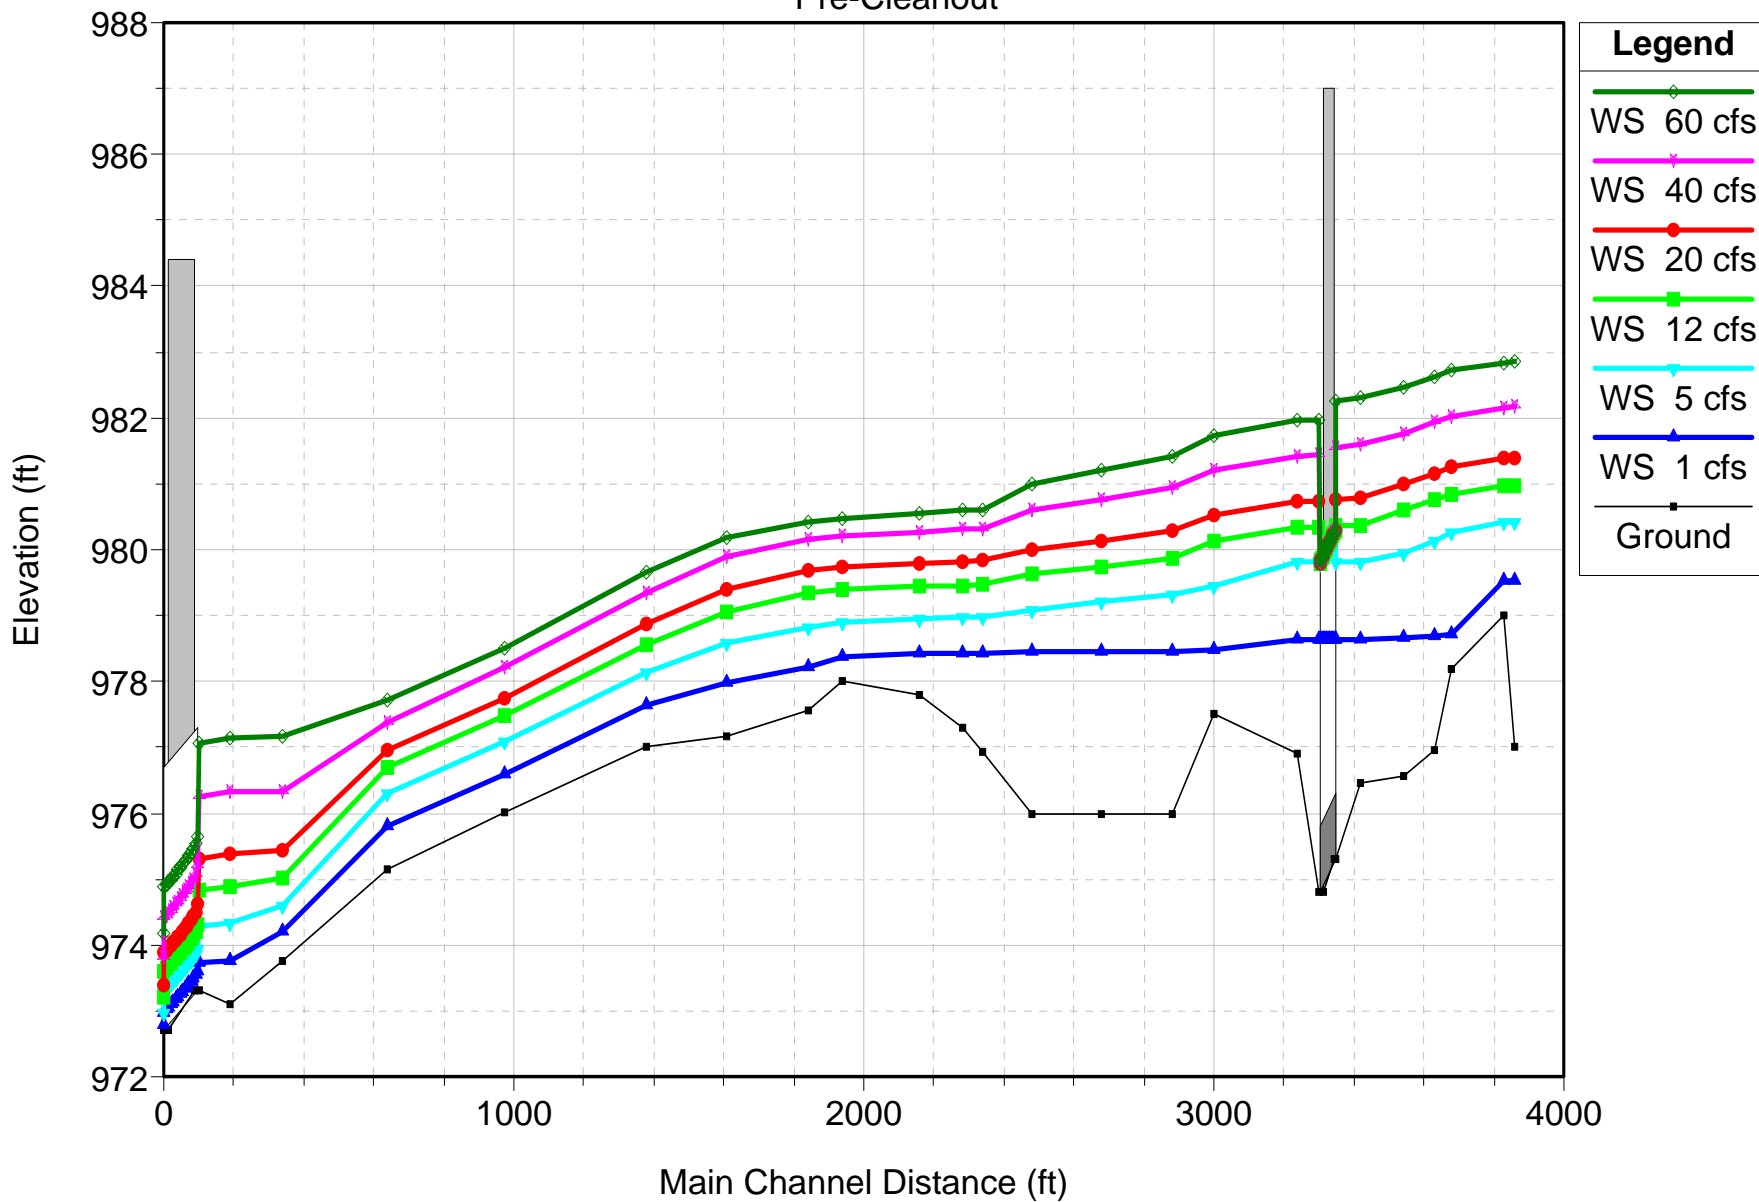
Sarah Lake Outlet Channel Pre-Cleanout

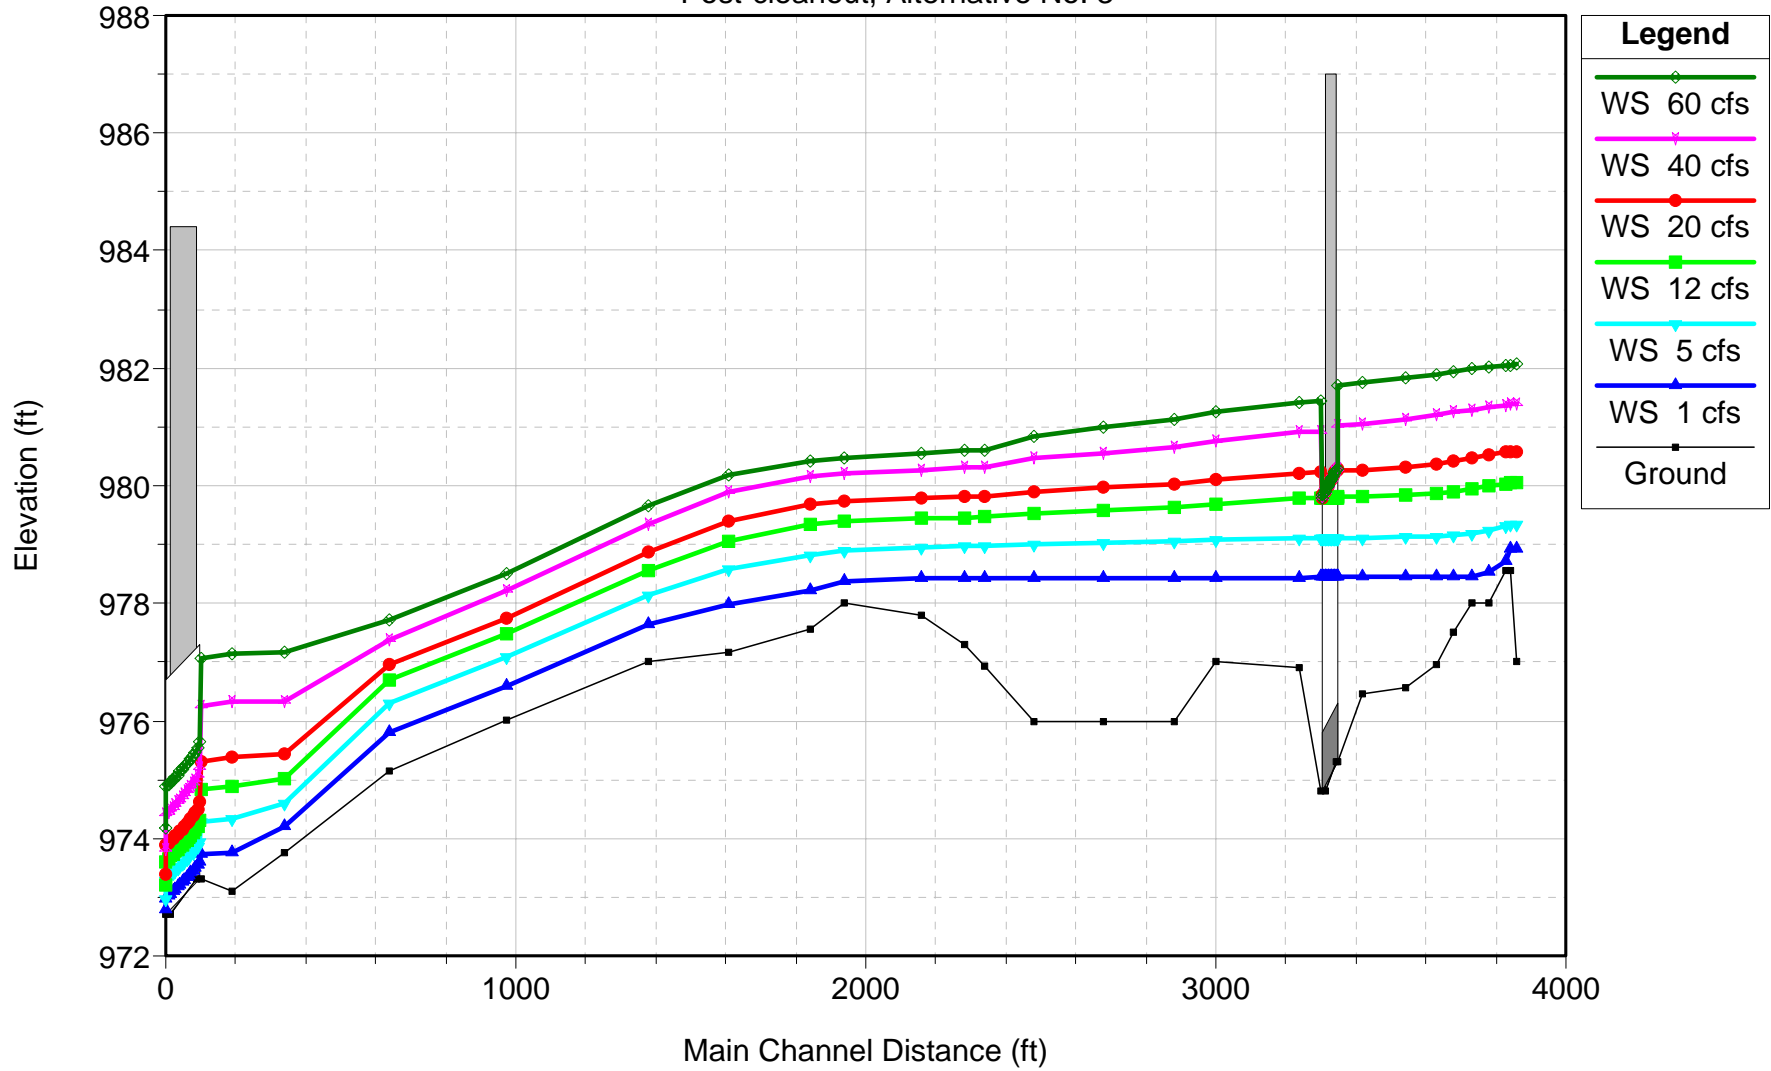
Sarah Lake Outlet Channel
Post-cleanout, Alternative No. 3

<u>Runout</u>	<u>upper weir</u>	<u>above Alt. No.1</u>
Alternative 1:	2 ft @ 978.3	978.9	0.0
Alternative 2:	2 ft @ 978.8	979.3	0.23 ft
Alternative 3:	2 ft @ 978.55	979.05	0.10 ft
Alternative 4:	6 ft @ 978.8	979.2	<i>0.10 ft</i>
Alternative 5:	4 ft @ 978.7	979.1	0.12 ft

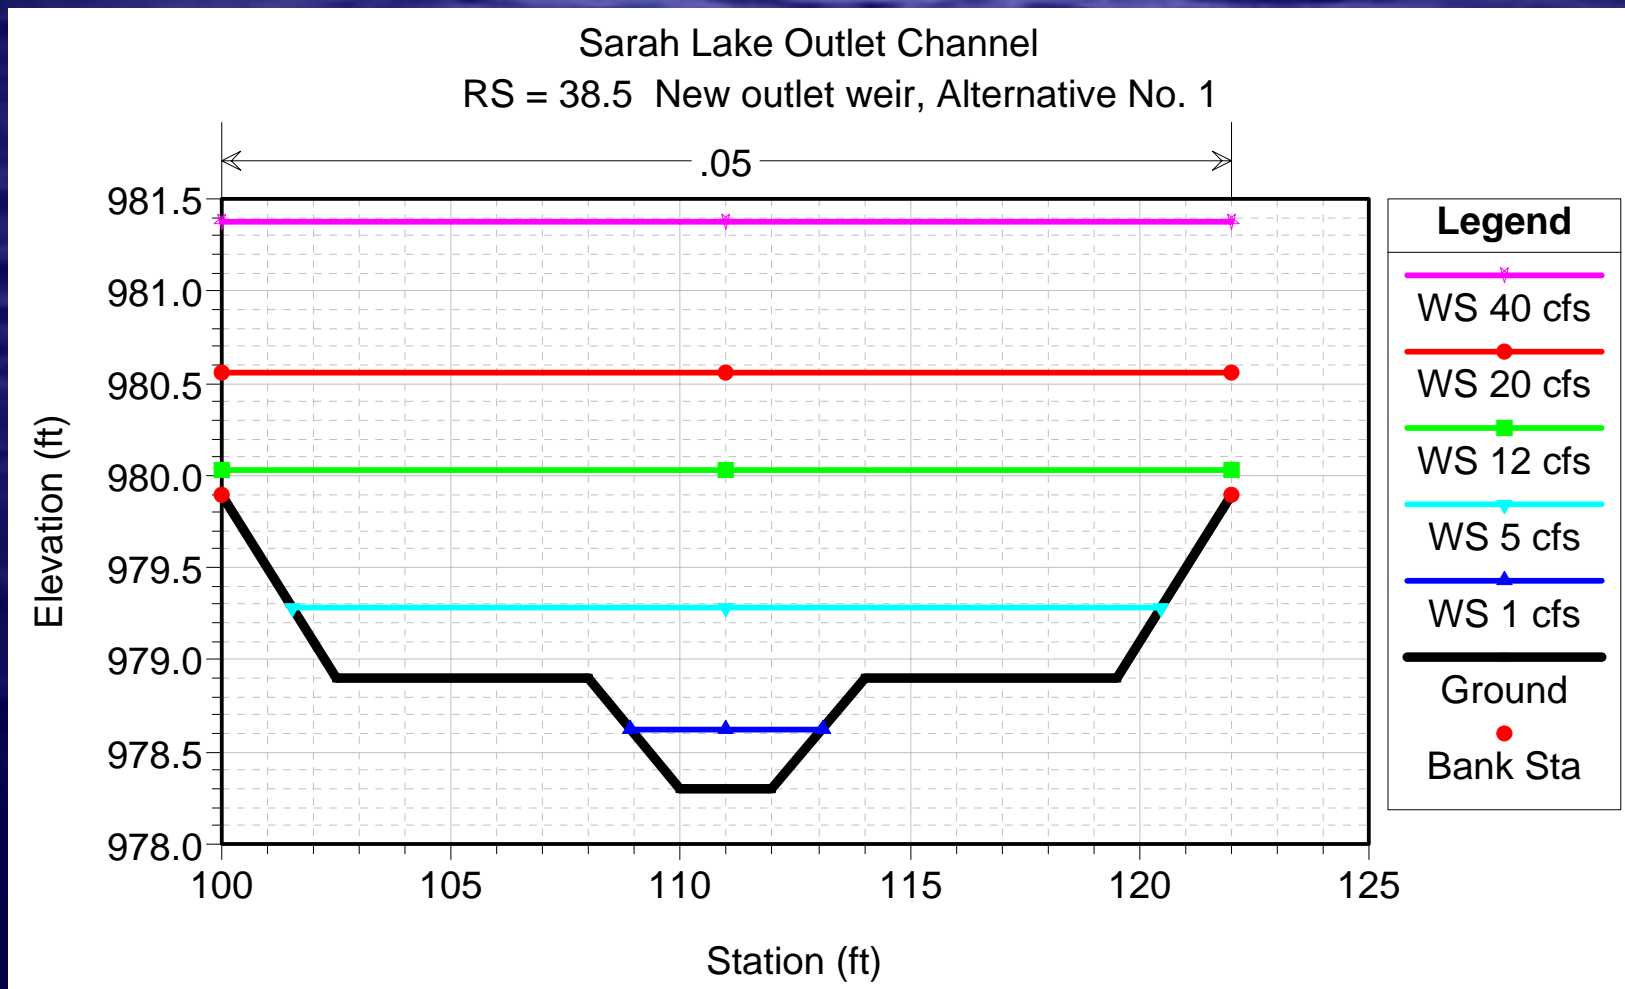
Cable Crete Alternative 1

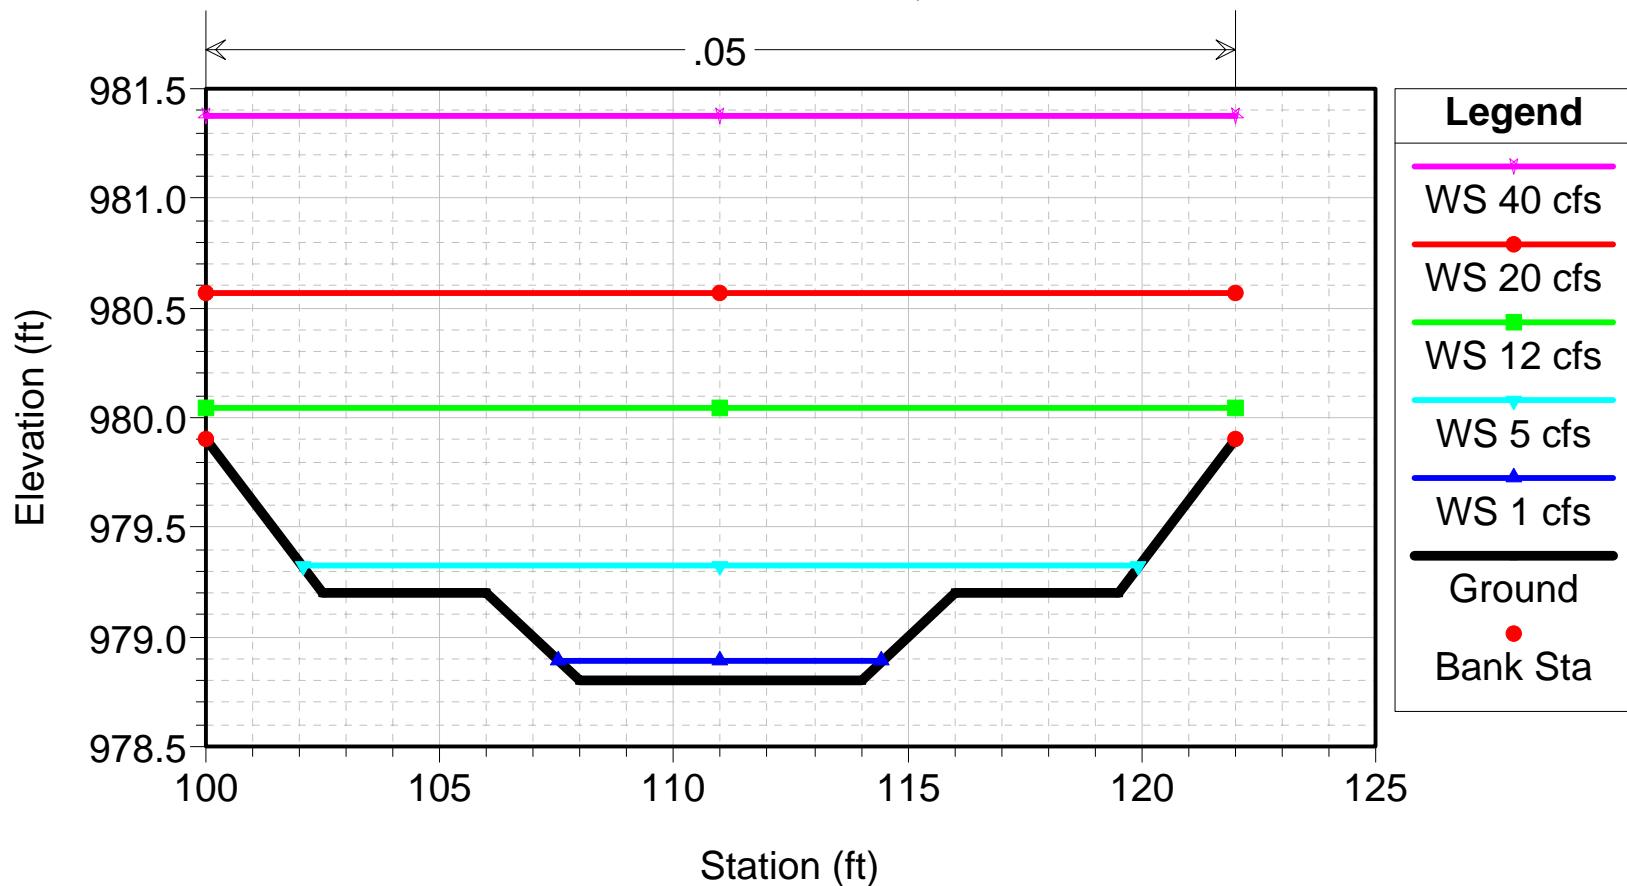
Alternative 4

Sarah Lake Outlet Channel
RS = 38.5 New outlet weir, Alternative No. 4

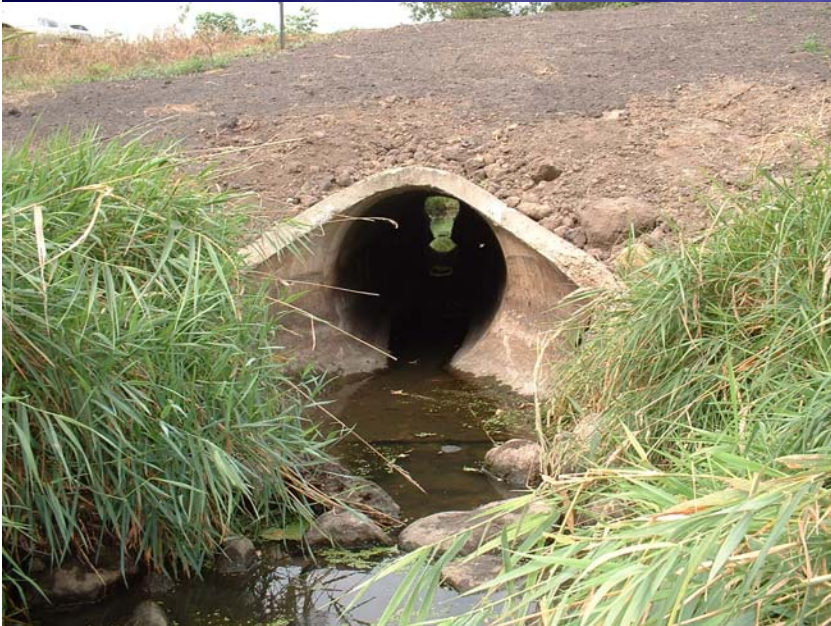
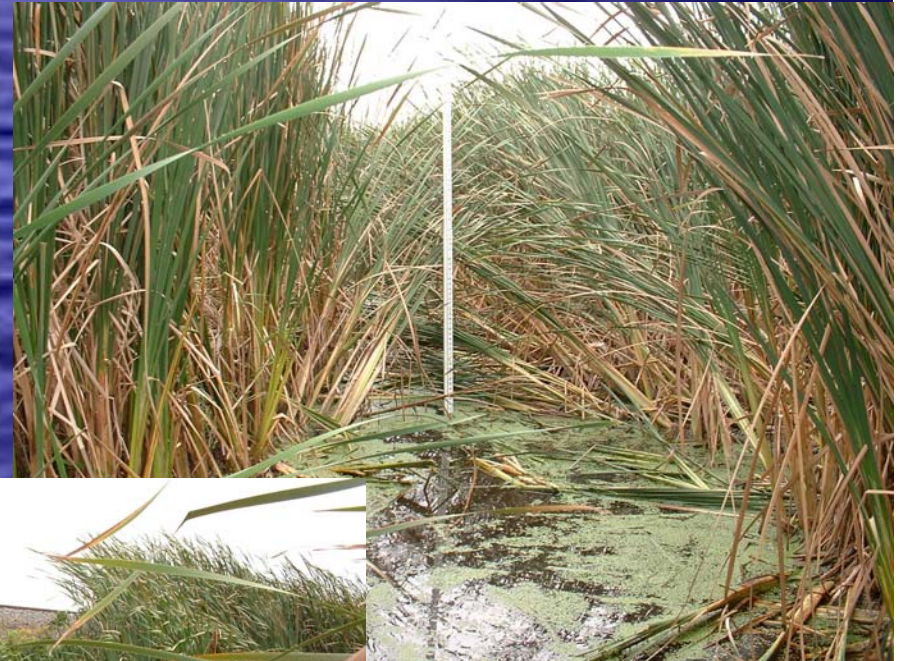
The Outlet - Sept. 2003

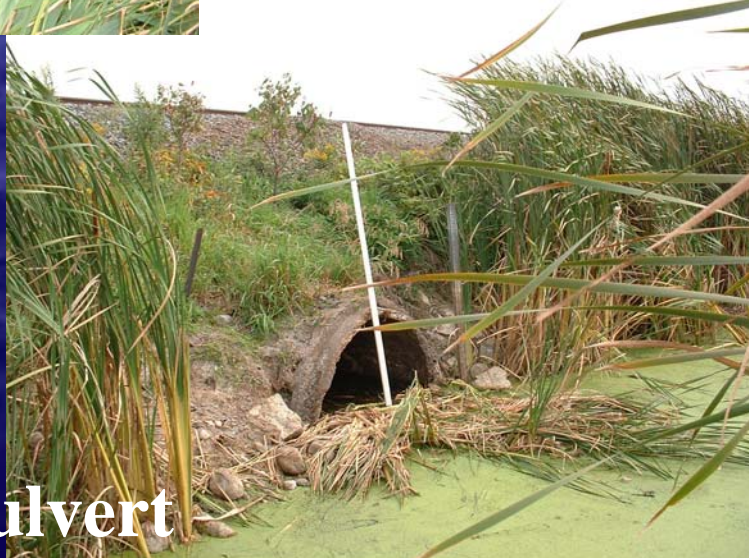
Co. Rd. 92

Channel in
27-365W

U.S. end 60" RR Culvert
